**RAGCHEW**

**FEBRUARY 2022**

# Airmec Attenuator Type 397: Some Basic Tests

Richard Tofts MOHNK. 29/11/21

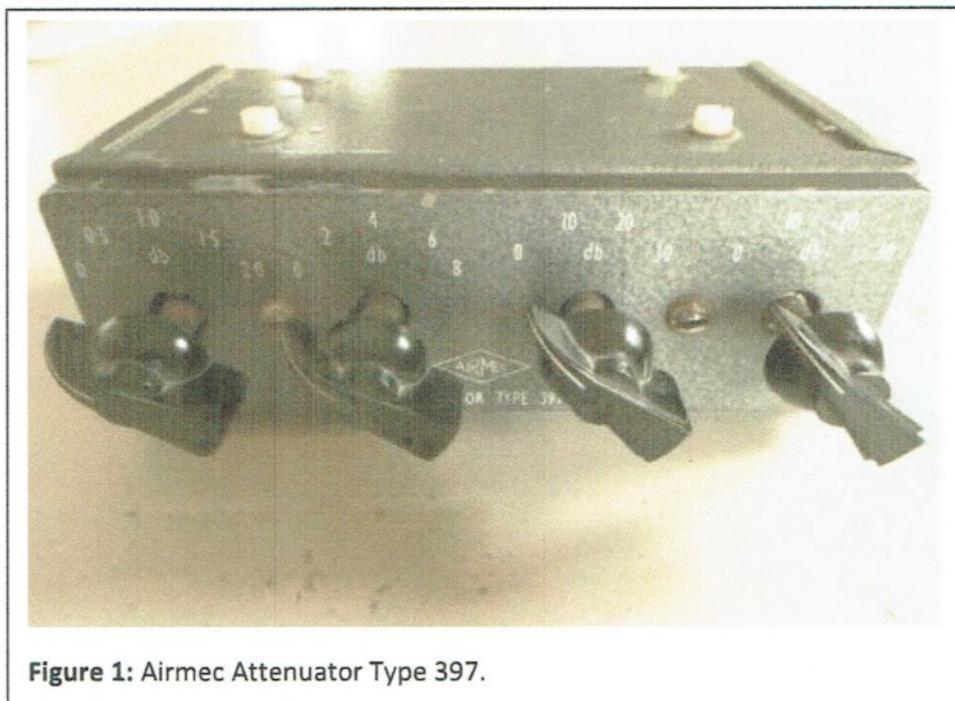
Figure 1: Airmec Attenuator Type 397.

The attenuator is adjustable by means of four rotary switches. From left to right, the levels of attenuation are given as:

- Switch 1 – 0, 0.5, 1.0, 1.5 & 2.0 dB
- Switch 2 – 0, 2, 4, 6 & 8 dB
- Switches 3 and 4 (identical) – 0, 10, 20 & 30 dB

The four switches operate independently and, on this basis, the attenuator provides adjustable attenuation in increments of 0.5 dB from 0 dB to 70 dB.

An image of the device is shown at Figure 1. Just from general appearance and the type of construction one imagines that it might date from somewhere around the 1960s or 1970s era.

I have no idea of the power rating of the device. A brief online search for a manual was unsuccessful although my efforts were by no means exhaustive. The attenuator is solidly constructed and one imagines that it might comfortably accept QRP power levels (up to perhaps 10 W). Opening the box to examine the resistors might shed further light on this.

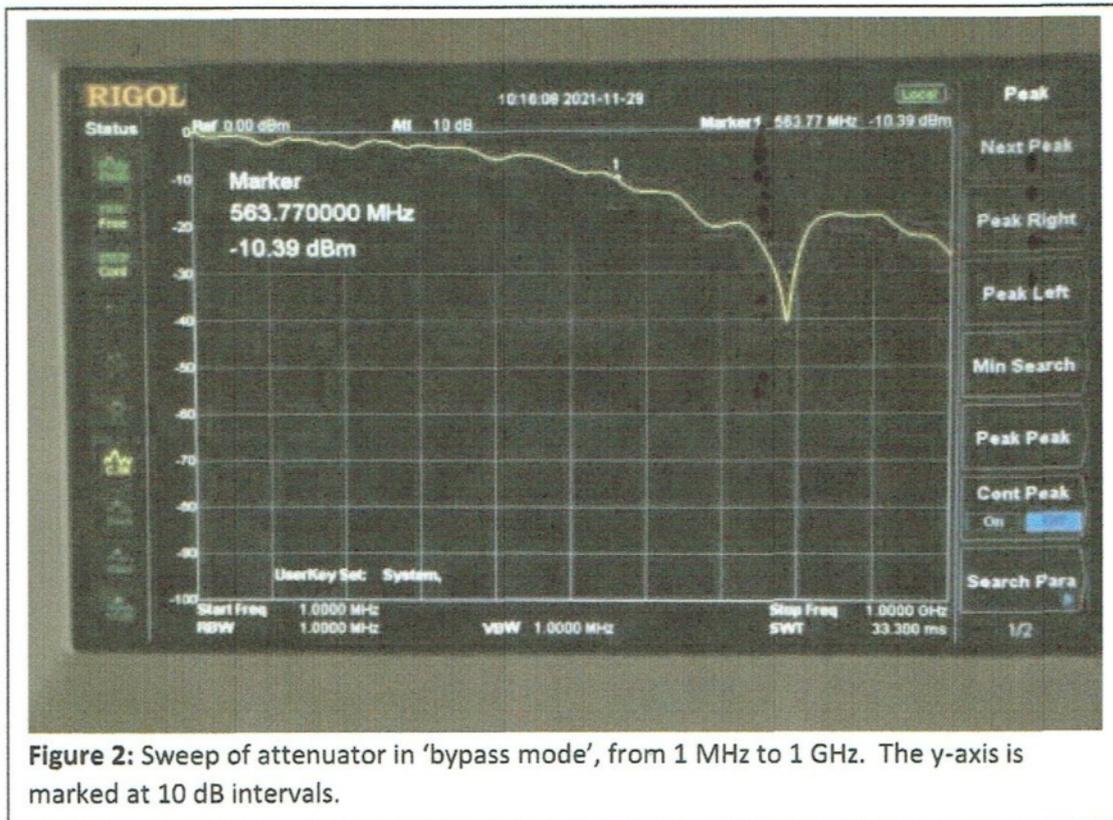
**Figure 2:** Sweep of attenuator in 'bypass mode', from 1 MHz to 1 GHz. The y-axis is marked at 10 dB intervals.

A perfect device would, of course, give rise to a horizontal trace along the top of the screen (i.e. at 0 dB). Figure 2 shows how the Airmec 397 departs from this ideal situation. The level of accuracy deemed acceptable will naturally depend on the job in hand, but measurements taken from this trace indicate that the error is never worse than 3 dB until the frequency reaches 212 MHz. Once the frequency exceeds around 300 MHz the situation deteriorates more markedly. By around 563 MHz the response is 10 dB down and the error is as much as 40 dB at around 780 MHz where there is a pronounced notch.

The first test was simply to provide an overview. For this, the attenuator was inserted between TG output and SA input and all the attenuator switches were set to bypass (i.e. 0 dB attenuation). The response of the device is shown at Figure 2 overleaf.

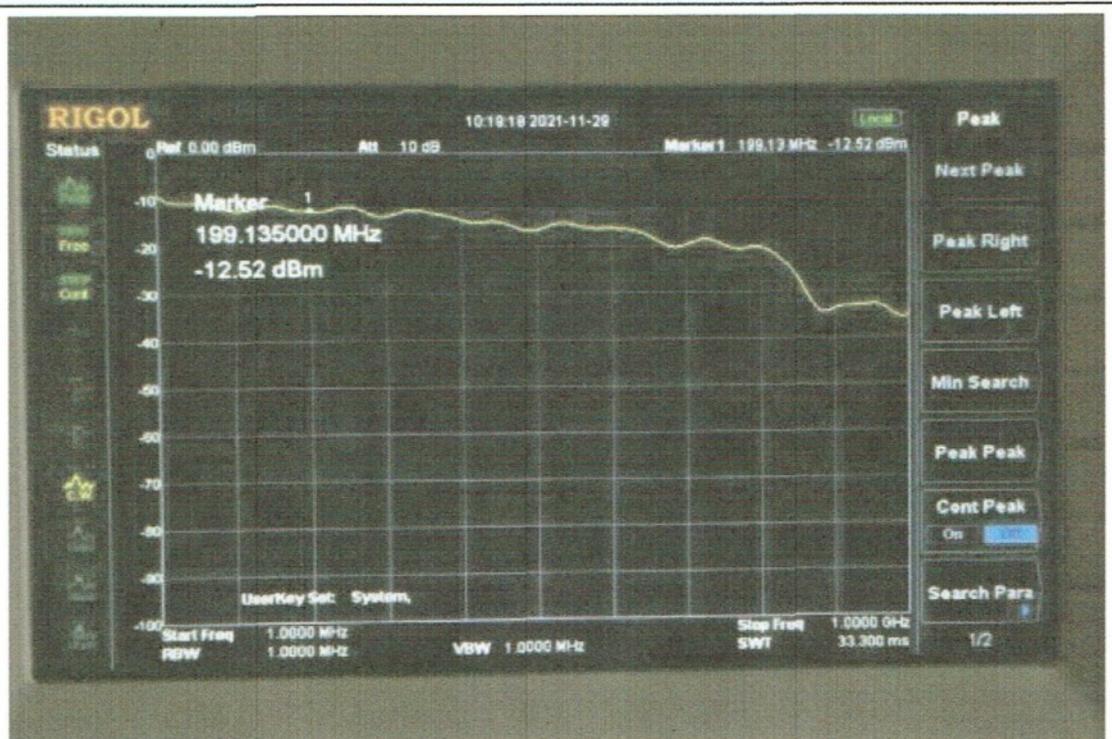
Figure 3: Response of attenuator from 1 MHz to 1 GHz with 10 dB attenuation added.

Introduction of varying levels of attenuation produces results that are somewhat complex. Across the HF range (up to 30 MHz) the accuracy of the attenuation was found to be within 0.5 dB of what was anticipated based on the values marked on the front panel. At higher frequencies, the attenuation departed from the ideal flat response, but the shape of the response was generally not simply that of a fixed additional attenuation superimposed on the 'bypass response' of Figure 2. In other words, adding (say) 20 dB of attenuation does not result in a response exactly like that shown in Figure 2 but simply diminished in magnitude by 20 dB. Instead, adding attenuation tends to iron out the bumps in the response to a greater or lesser extent, more so with higher attenuation levels. And at the highest frequencies examined here, the level of attenuation is reduced to less than what it should be in contrast to the situation in 'bypass mode'. Examples of the response from 1 MHz to 1 GHz (like Figure 2) but with 10, 20 and 30 dB added attenuation are shown at Figures 3 to 5. For this, a single switch was used and the others were bypassed, but the results appeared broadly similar if the 30 dB of attenuation consisted of 10 dB on one switch and 20 dB on another. Compare Figures 3 and 5 for contrasting response shapes when 10 dB and 30 dB attenuation are added respectively.

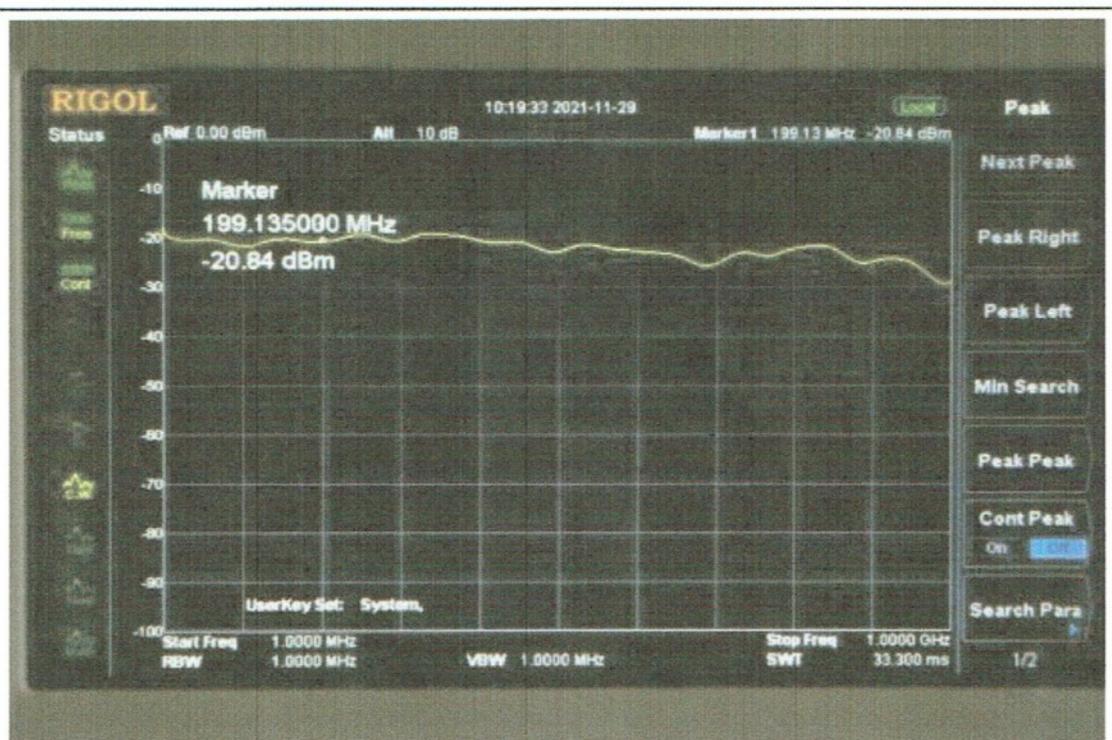
Figure 4: Response of attenuator from 1 MHz to 1 GHz with 20 dB attenuation added.

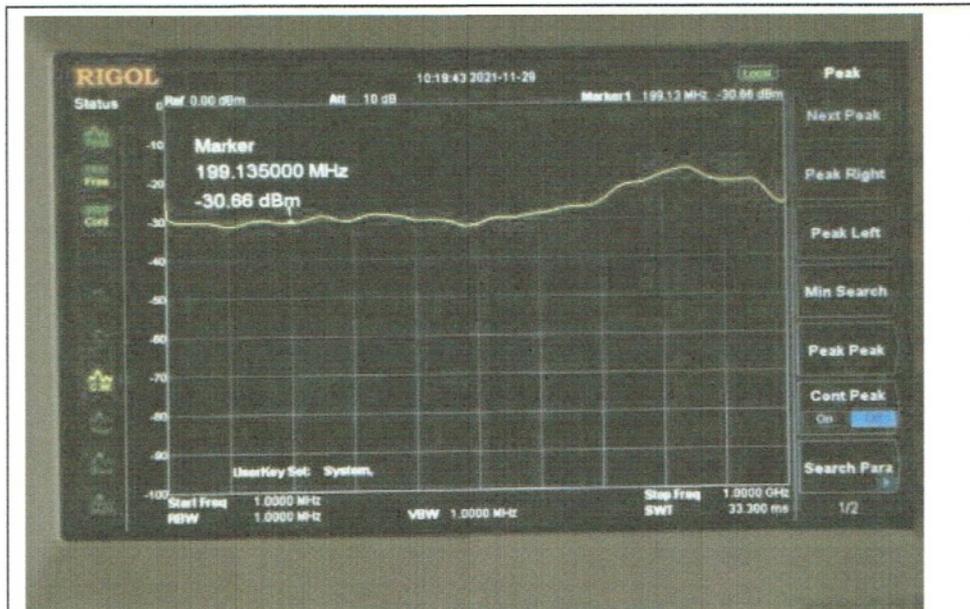
**Figure 5:** Response of attenuator from 1 MHz to 1 GHz with 30 dB attenuation added.

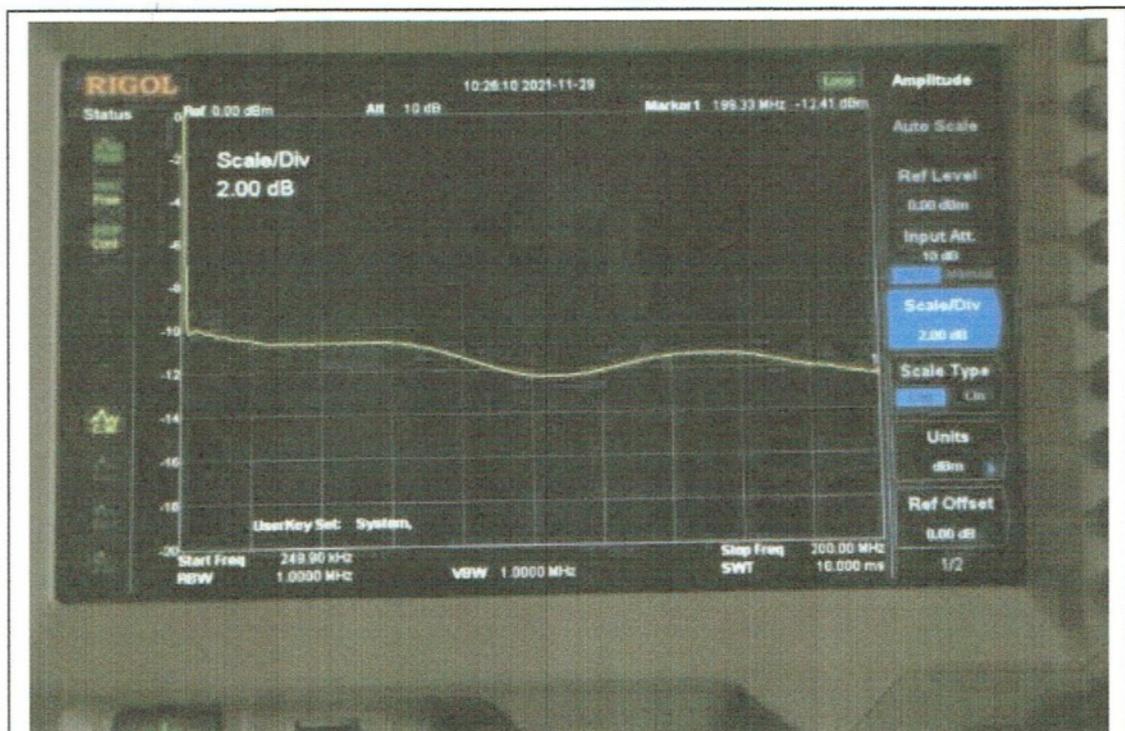
**Figure 6:** Response of attenuator from 250 kHz to 200 MHz with 10 dB attenuation added. Note that the vertical scale is now 2 dB per division, not 10 dB as in the previous figures.

It seems unlikely that the Airmec 397 attenuator was designed for the highest frequencies used here and it would therefore probably be unfair to criticise it for shortcomings at VHF or UHF. Overall, the tests indicate that the device offers a level of performance that would probably meet most amateur needs at HF and possibly a little beyond this, depending on the level of accuracy required. As a final example, Figure 6 shows at a greater level of resolution an example response to 200 MHz with 10 dB of attenuation being inserted into the circuit. The vertical resolution in this case is 2 dB rather than the 10 dB used previously.
